Roof Evaluation

Friday Harbor Elementary School
95 Grover Street
Friday Harbor, Washington

Project No. 1007-07A1

August 19, 2010

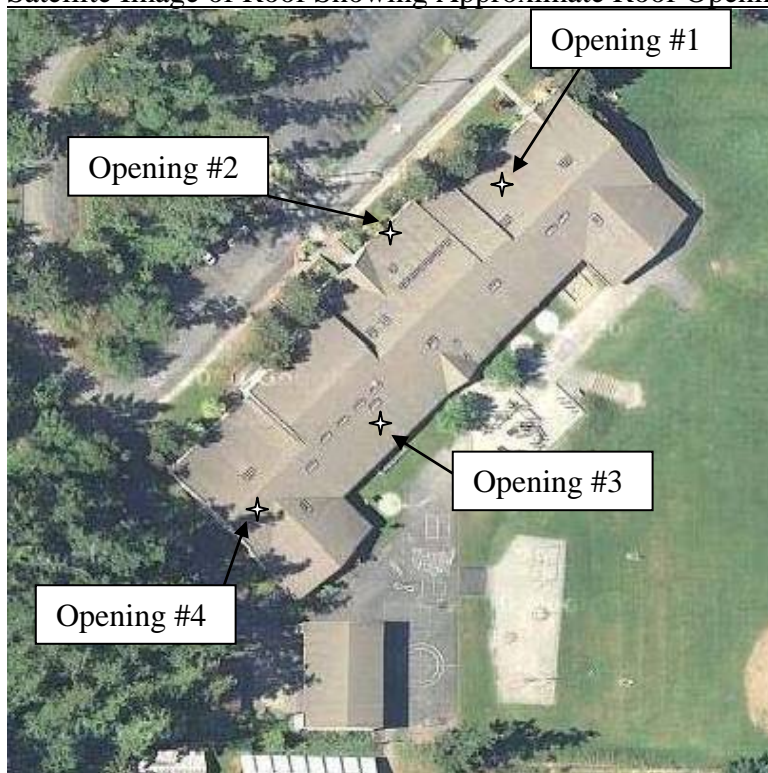
Satellite Image of Roof Showing Approximate Roof Opening Locations

Four roof openings were performed during the August 4, 2010 site visit in an effort to further review the existing roof conditions and gain a better understanding of the roof issues. Generally, openings included removal through the plywood roof deck. As previously indicated, roof openings were performed by Northwest Roof Solutions, who also reinstalled roofing once openings were complete. Roof opening locations and observations are listed below. For purposes of simplifying building orientation, the main front entrance elevation of the building will be considered the north elevation.

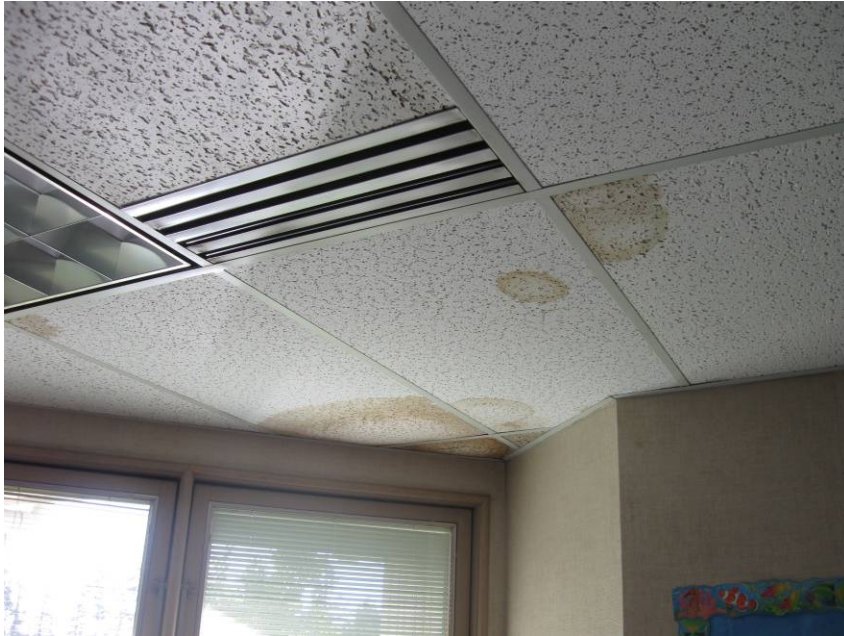
Photo #5

Classroom #17,
southwest area of the
building: Water stains
on the ceiling tiles as a
result of past leakage.
Water stains generally
align beneath a valley
transition.

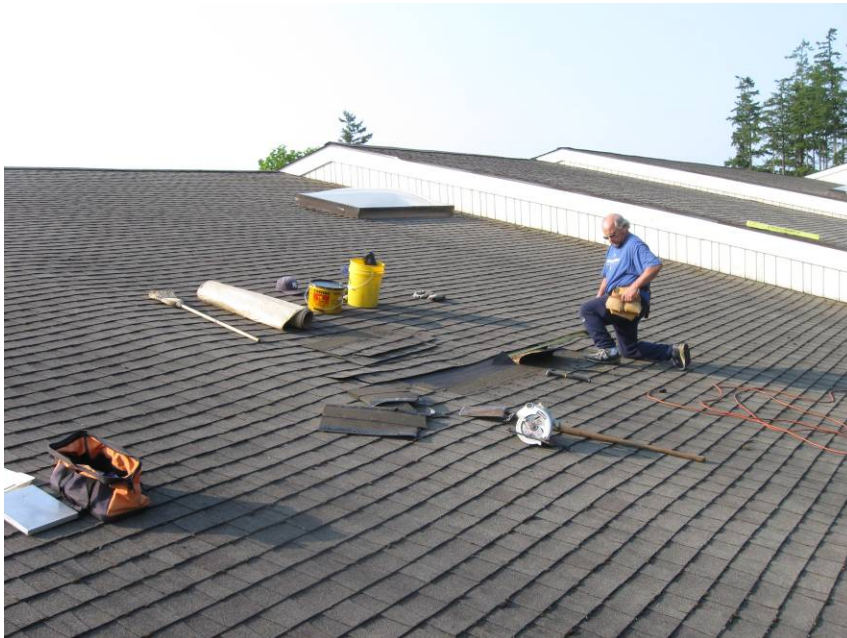
Photo #10

1. **Opening #1**, north slope, northeast roof area, field of roof, approximately 4 foot by 4 foot opening through the plywood deck.

Roof opening #1, north slope, northeast roof area, field of roof, approximately 4 foot by 4 foot opening through the plywood deck.

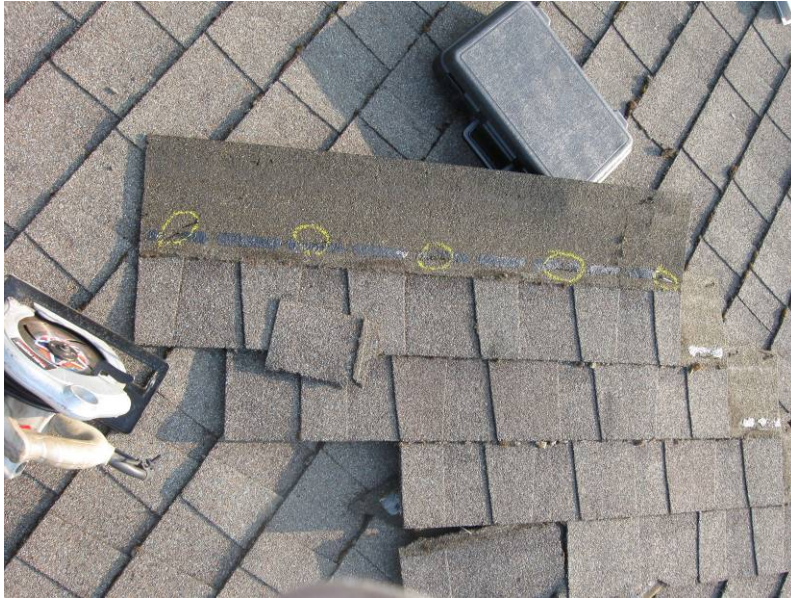
Photo #11

The shingles are fastened with approximately six 1 inch staples per shingle often positioned upslope of the manufacturer nail line.

Roof opening #1, north slope, northeast roof area, field of roof:
Shingles are secured with 6 staples per shingle generally positioned upslope of the manufacturer nail line.

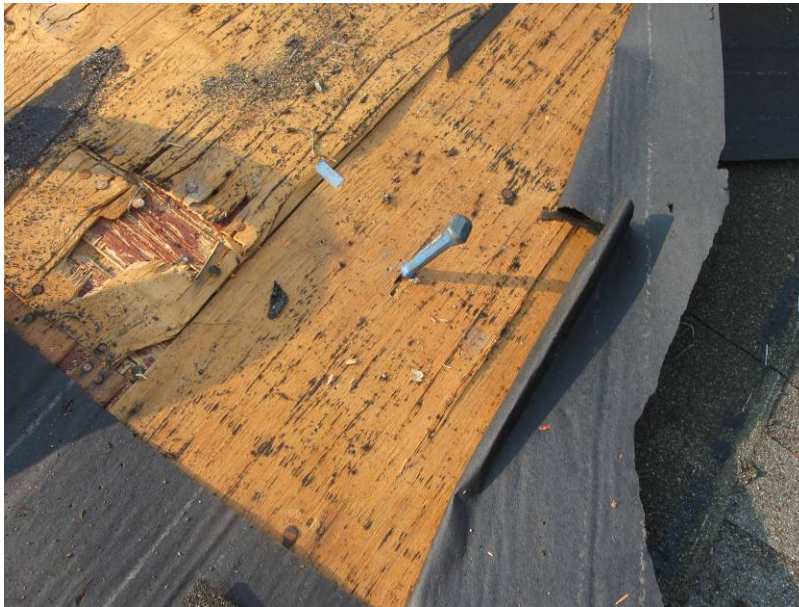
Photo #12

Observations: Two of the three separate pieces of plywood exhibited deterioration resulting in delamination of the plies and loss of structural integrity. A scratch awl was pushed through the plywood with minimal effort.

Roof opening #1, north slope, northeast roof area, field of roof, approximately 4 foot by 4 foot opening through the plywood deck:
Observed deterioration and loss of structural integrity of the plywood sheathing. A scratch awl was pushed through the plywood with little effort at this location.

All deteriorated plywood should be removed and replaced with new. Soffit vents should remain in place for venting of the soffit cavity but any vent inlet (at the openings above the wall plane) should be fully blocked and the insulation plane between the perimeter walls and roof deck should be made continuous. Ridge vents should be blocked as well.

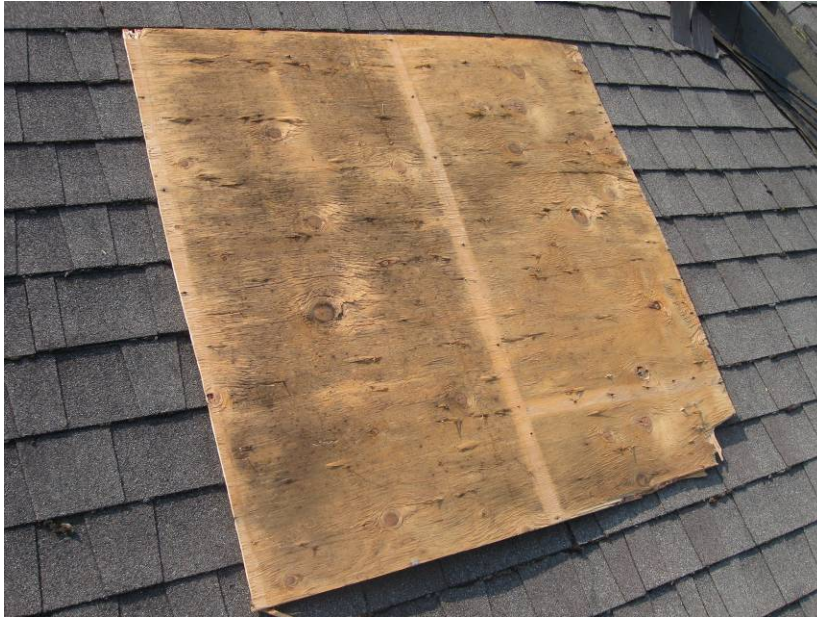
Photo #13

What appeared to be surface organic growth was observed on the underside of the plywood sheathing and on a few truss cords, though appeared relatively minimal. All nails securing the plywood were rusted.

Roof opening #1, north slope, northeast roof area, field of roof, approximately 4 foot by 4 foot opening through the plywood deck: Observed what appeared to be surface fungal growth on the underside of the plywood roof sheathing, that may be the result of condensation.

1. The existing siding at roof-to-wall transitions should be removed and replaced with new, over a properly installed vapor retarder.
2. Review and remediation of any organic growth should be performed/directed by a certified industrial hygienist.

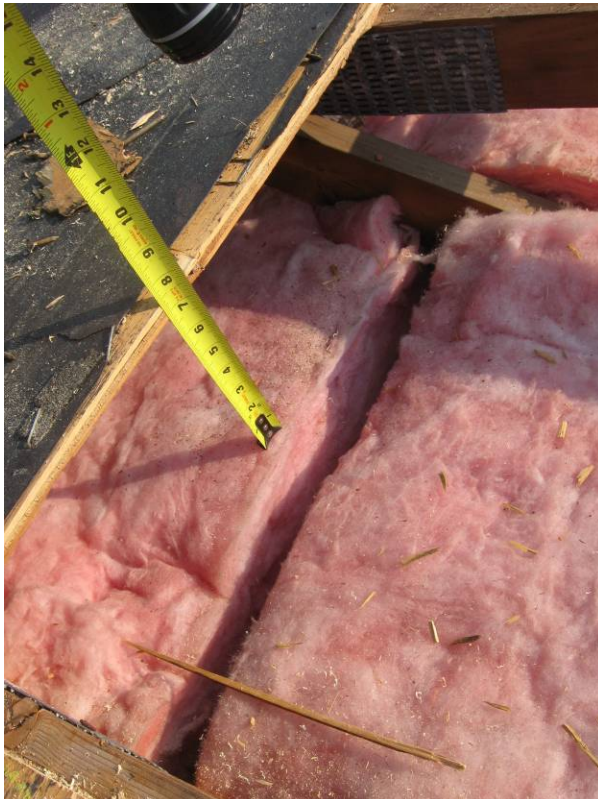
Photo #14

The vent cavity below the roof deck measured approximately 6 inches and appeared relatively unrestricted.

Roof opening #1, north slope, northeast roof area, field of roof, approximately 4 foot by 4 foot opening through the plywood deck: Approximately 7 inch vent gap between the existing batt insulation and the underside of the roof deck.

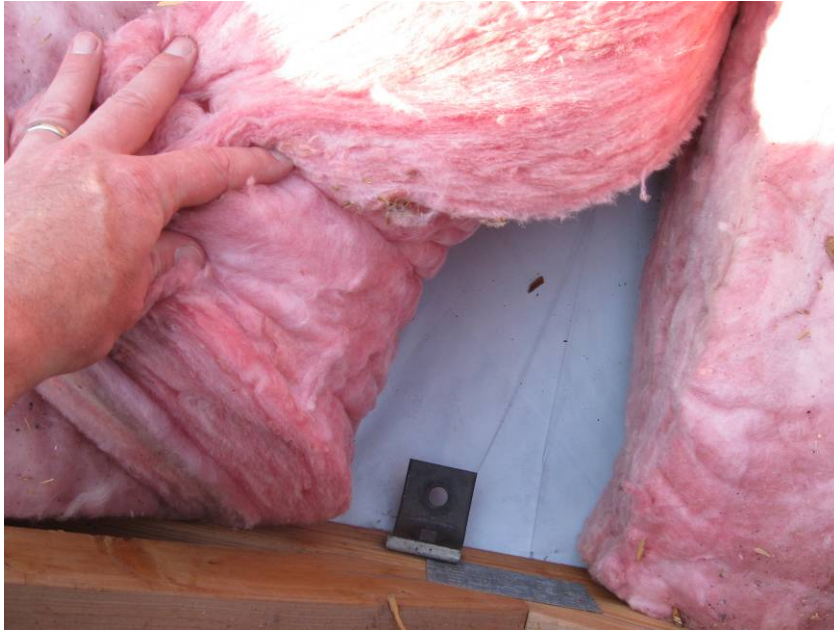
Photo #15

Roof opening #1, north slope, northeast roof area, field of roof, approximately 4 foot by 4 foot opening through the plywood deck: A piece of batt insulation was lifted to expose the visqueen vapor retarder installed on the inboard side of the insulation assembly, which is appropriate.

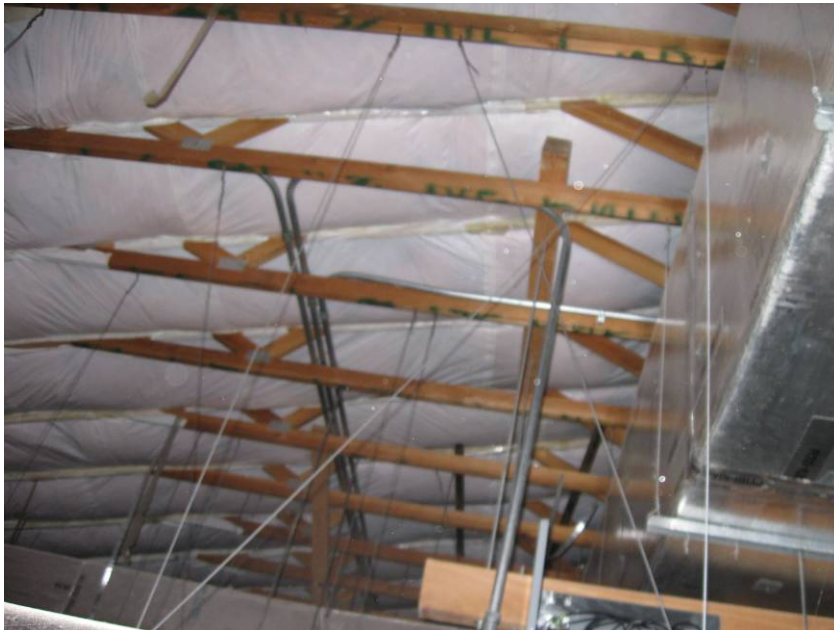
Photo #16

Interior view of the underside of the insulation assembly beneath the roof. Insulation and vapor retarder are integrated between the web trusses (spaced at 24 inches on center). Typical vapor retarder seams and transition points detailed with tape.

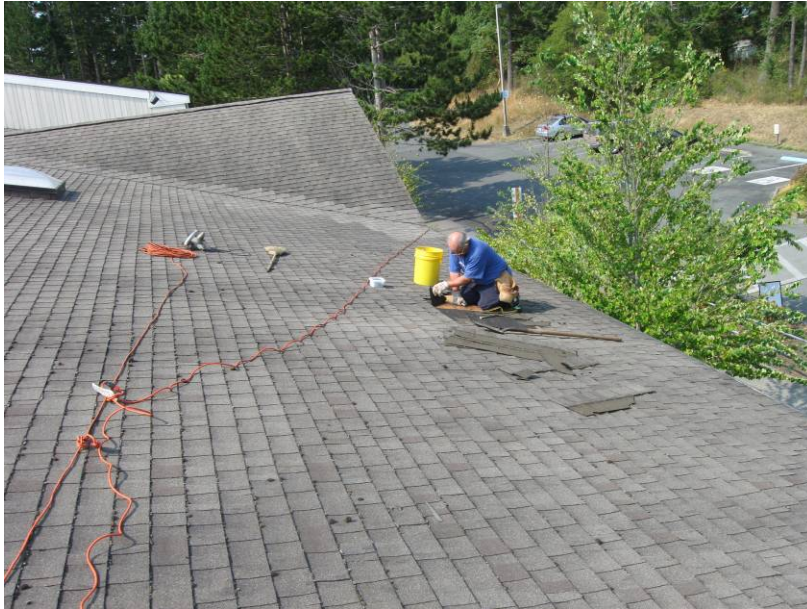
Photo #17

2. **Opening #2**, north slope, central east roof area, downslope roof area, approximately 4 foot by 4 foot opening through the plywood deck.

Roof opening #2, north slope, central east roof area, downslope roof area, approximately 4 foot by 4 foot opening through the plywood deck.

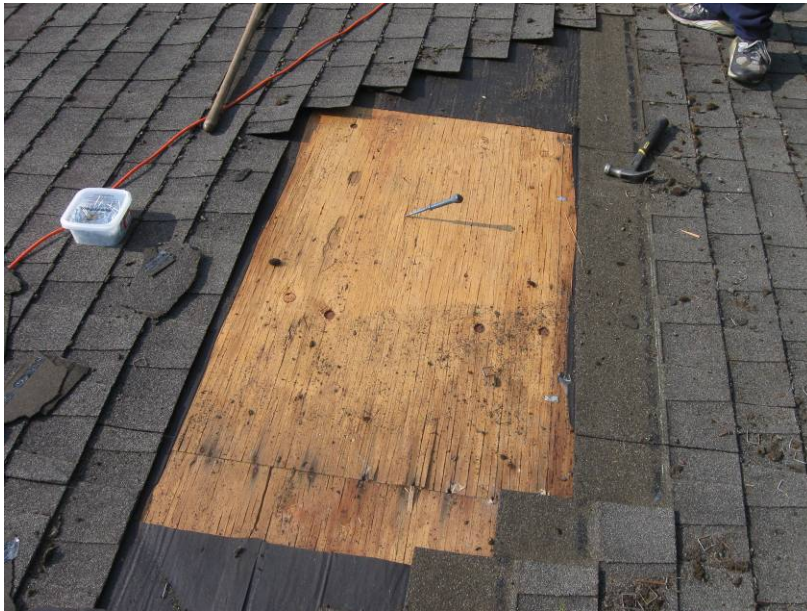
Photo #18

Observations: Deterioration of plywood resulting in delamination of the surface plies and loss of structural integrity.

Roof opening #2, north slope, central east roof area, downslope roof area, approximately 4 foot by 4 foot opening through the plywood deck: Observed moisture staining and deterioration of the plywood roof sheathing.

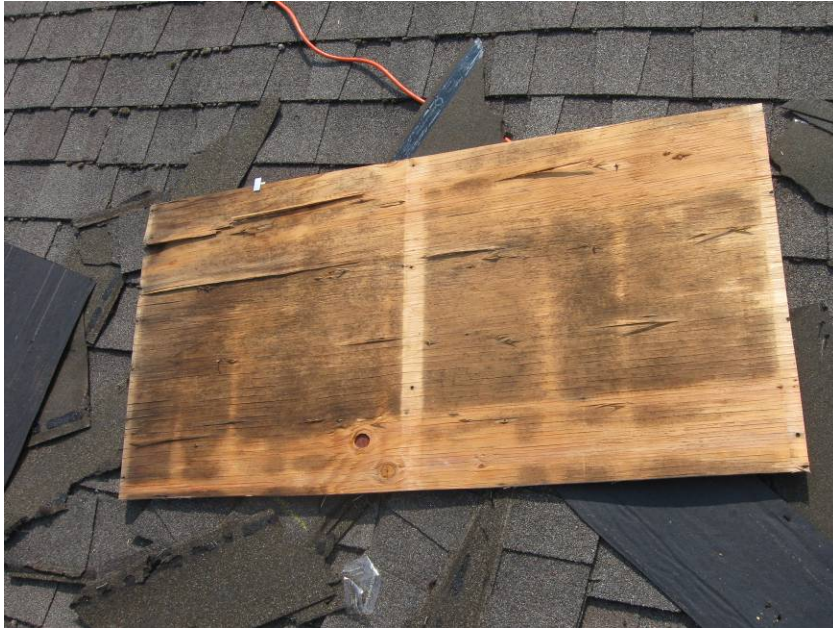
Photo #19

What appeared to be surface organic growth was observed on the underside of the plywood sheathing and on a few truss chords, though appeared relatively minimal. All nails securing the plywood were rusted.

Roof opening #2, north slope, central east roof area, downslope roof area, approximately 4 foot by 4 foot opening through the plywood deck: Observed what appeared to be surface fungal growth on the underside of the plywood roof sheathing, that may be the result of condensation.

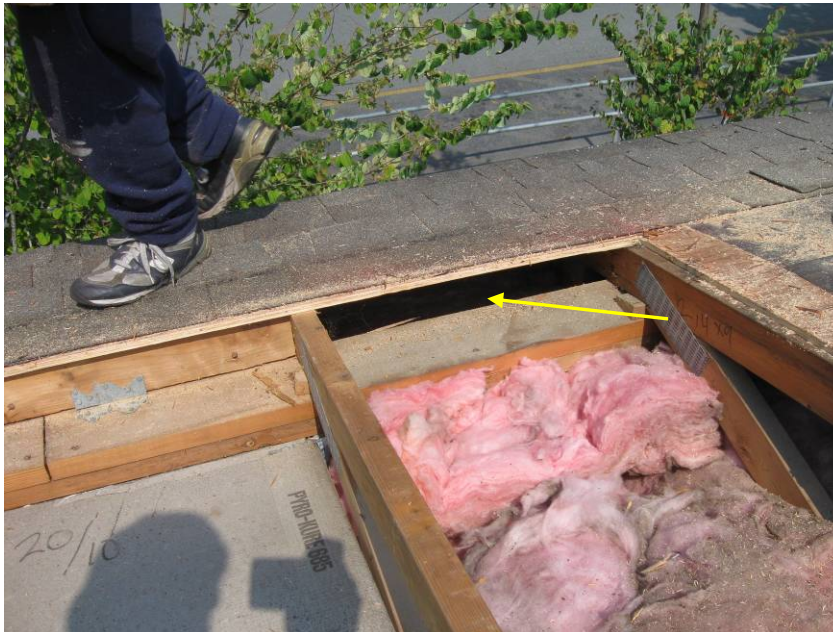
Photo #20

The soffit cavity is in-filled with batt insulation which is blocking the existing strip vent and prohibiting ventilation. Wood blocking is installed between the top of exterior wall framing and the roof sheathing at every other truss bay, which may or may not pose a venting issue, depending on how well cross-venting can occur between rafters.

Roof opening #2, north slope, central east roof area, downslope roof area, approximately 4 foot by 4 foot opening through the plywood deck: At the downslope eave, insulation was installed in the soffit cavity (arrow) and blocking the soffit vent. In this photo, the insulation that was installed in the soffit cavity had already been removed by this writer.

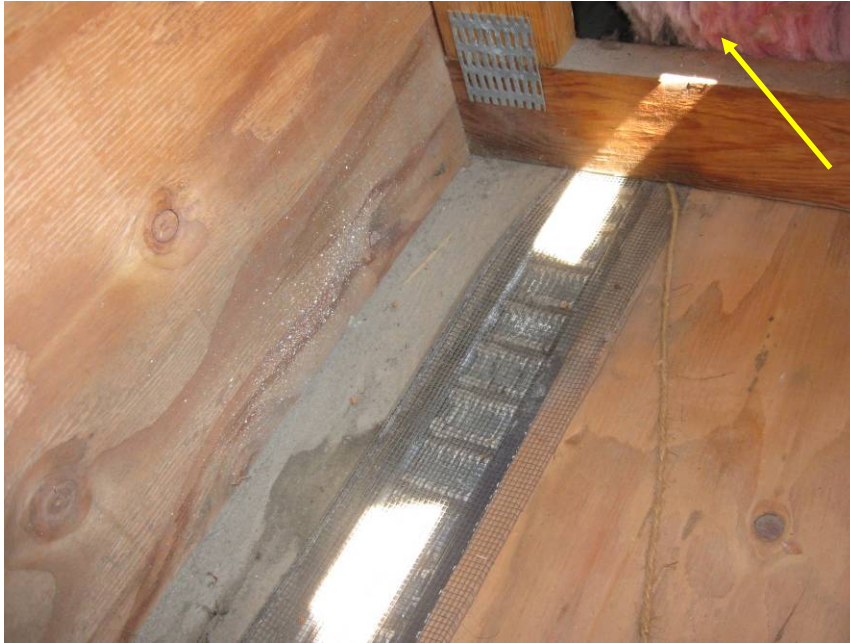
Photo #21

Roof opening #2, north slope, central east roof area, downslope roof area, approximately 4 foot by 4 foot opening through the plywood deck: Close up of the soffit cavity showing the top side of the strip vent which was blocked with batt insulation. Note the batt insulation installed in the adjacent cavity (top right corner of the photo) is blocking the vent as well.

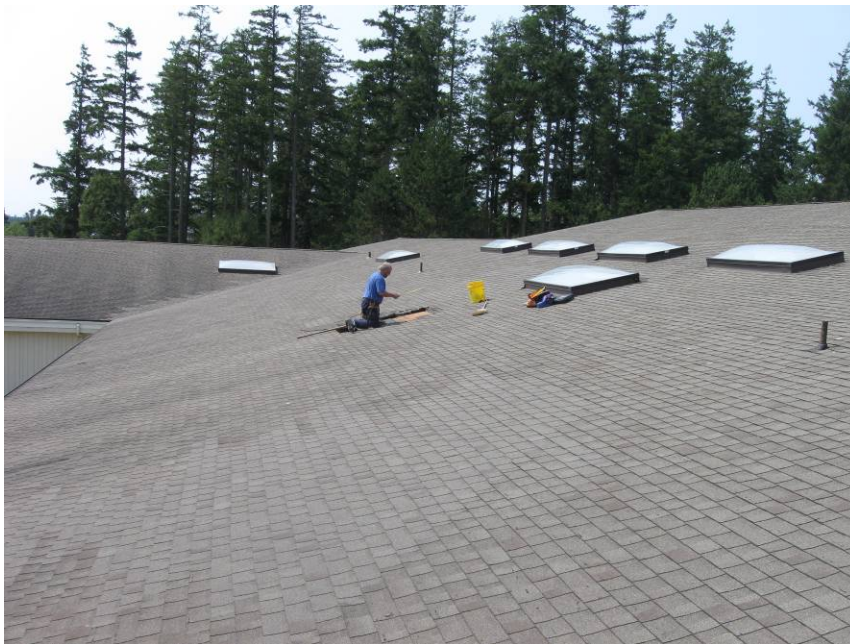
Photo #22

3. **Opening #3**, south slope, central west roof area, field of roof, approximately 2 foot by 4 foot opening through the plywood deck, downslope of skylight penetrations.

Roof opening #3 south slope, central west roof area, field of roof, approximately 2 foot by 4 foot opening through the plywood deck, downslope of skylight penetrations.

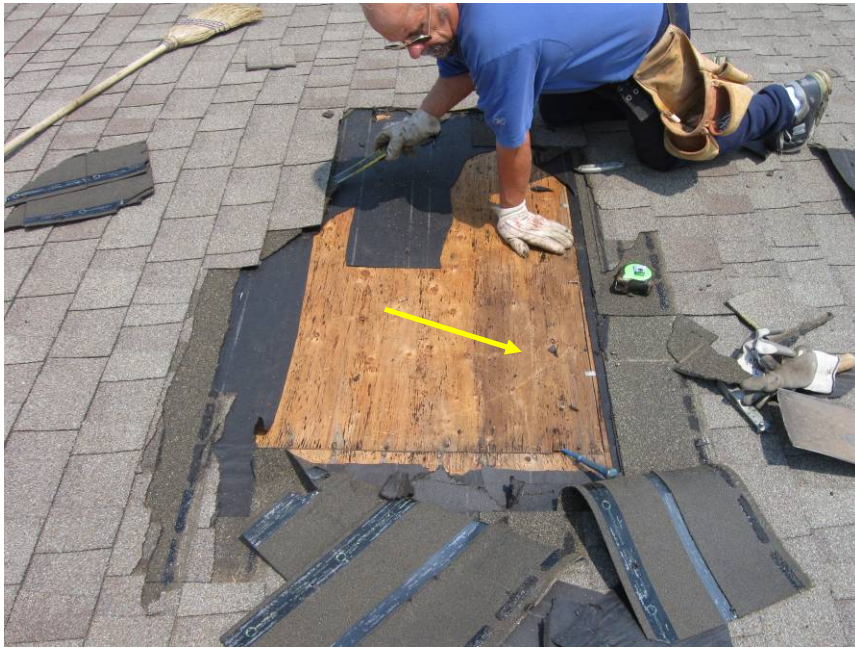
Photo #23

Observations: The plywood appeared to be in good condition. Water staining was observed at a corner of the plywood that appeared to be the result of leakage through the roof assembly.

Roof opening #3 south slope, central west roof area, field of roof, approximately 2 foot by 4 foot opening through the plywood deck, downslope of skylight penetrations: Observed water stainage on the downslope corner area of the plywood (arrow).

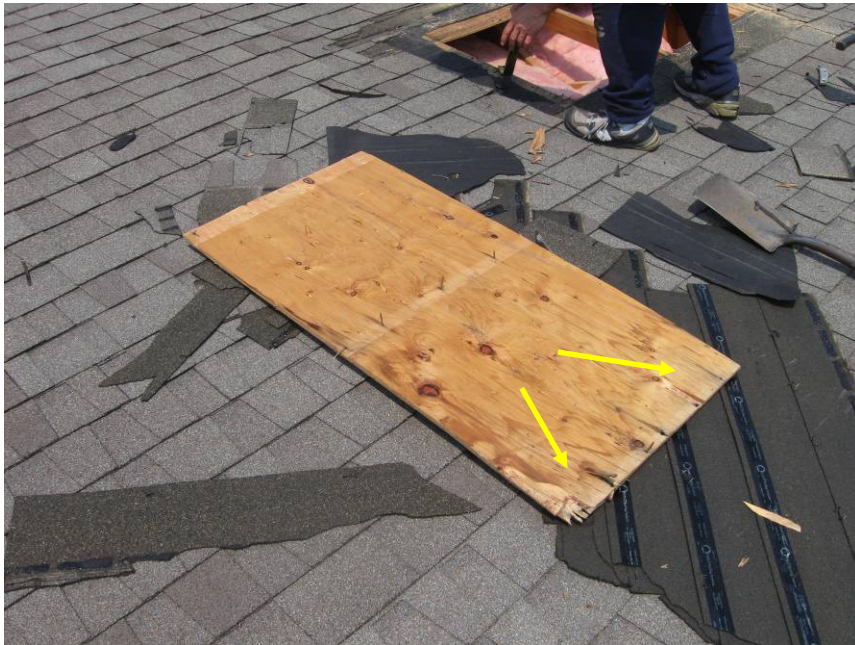
Photo #24

Roof opening #3 south slope, central west roof area, field of roof, approximately 2 foot by 4 foot opening through the plywood deck, downslope of skylight penetrations: Observed water stainage on the underside of the plywood (arrows).

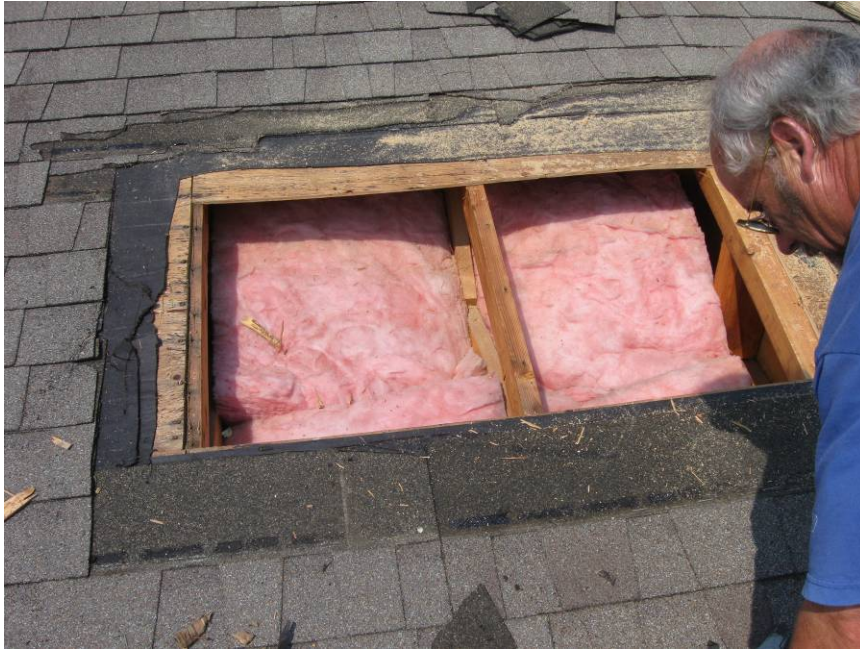
Photo #25

The vent cavity below the roof deck ranged from minimal to no gap (due to a raised piece of insulation) to approximately 8 inches.

Roof opening #3 south slope, central west roof area, field of roof, approximately 2 foot by 4 foot opening through the plywood deck, downslope of skylight penetrations:
Approximately 6 inch vent gap observed between the top surface of the batt insulation and the underside of the plywood sheathing.

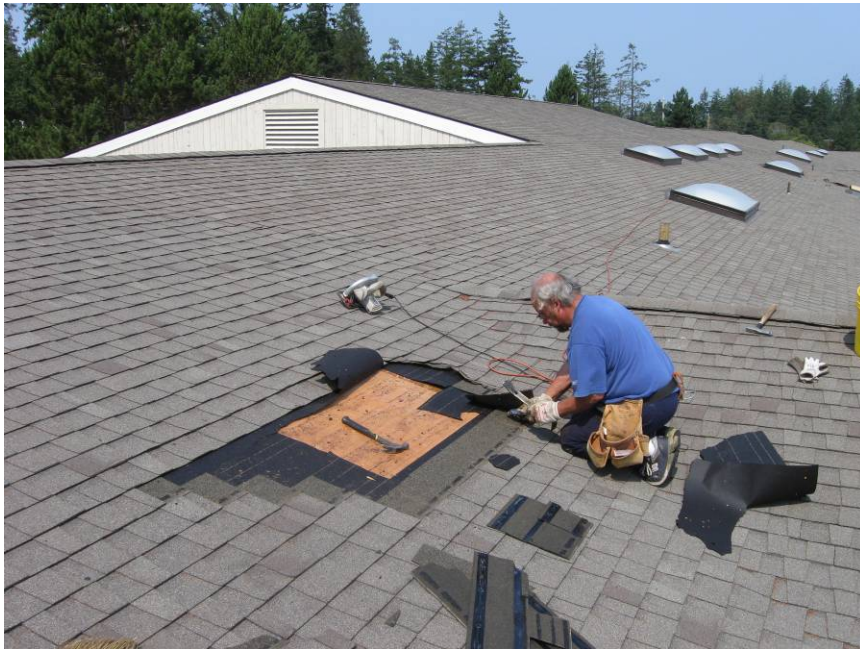
Photo #26

4. **Opening #4**, south slope, southwest roof area, field of roof, approximately 2 foot by 4 foot opening through the plywood deck, approximately 4 feet upslope of a valley transition. Note the roof area opened is an area of recent roof repair, which included removal of the existing roof and areas of plywood, and installation of new matching the existing.

Roof opening #4 south slope, southwest roof area, field of roof, approximately 2 foot by 4 foot opening through the plywood deck, approximately 4 feet upslope of a valley transition.

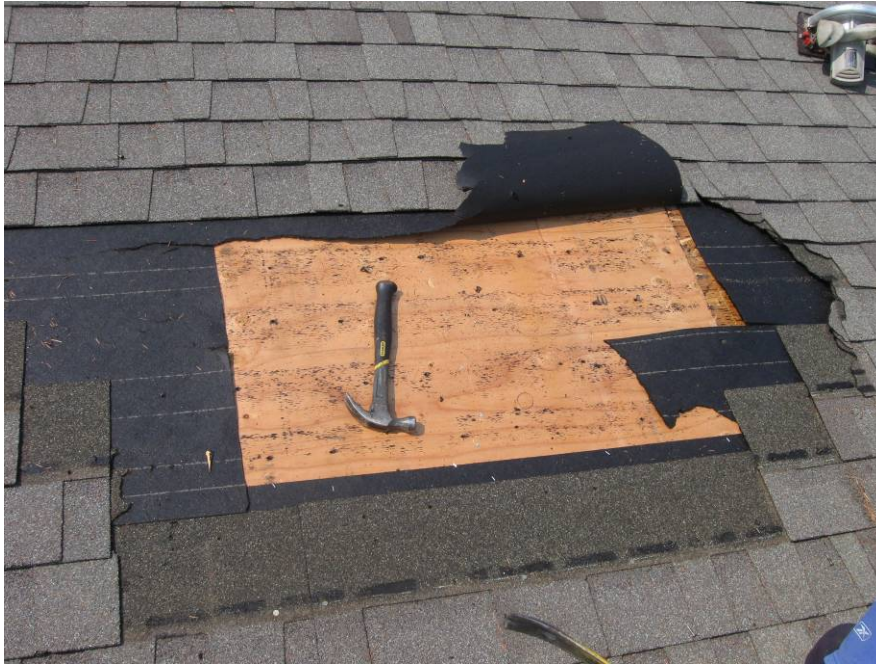
Photo #27

Observations: The plywood appeared to be new and in good shape. The nails on the adjacent older piece of plywood were rusted.

Roof opening #4 south slope, southwest roof area, field of roof, approximately 2 foot by 4 foot opening through the plywood deck, approximately 4 feet upslope of a valley transition: Plywood sheathing appeared to be recently installed as part of a roof repair.

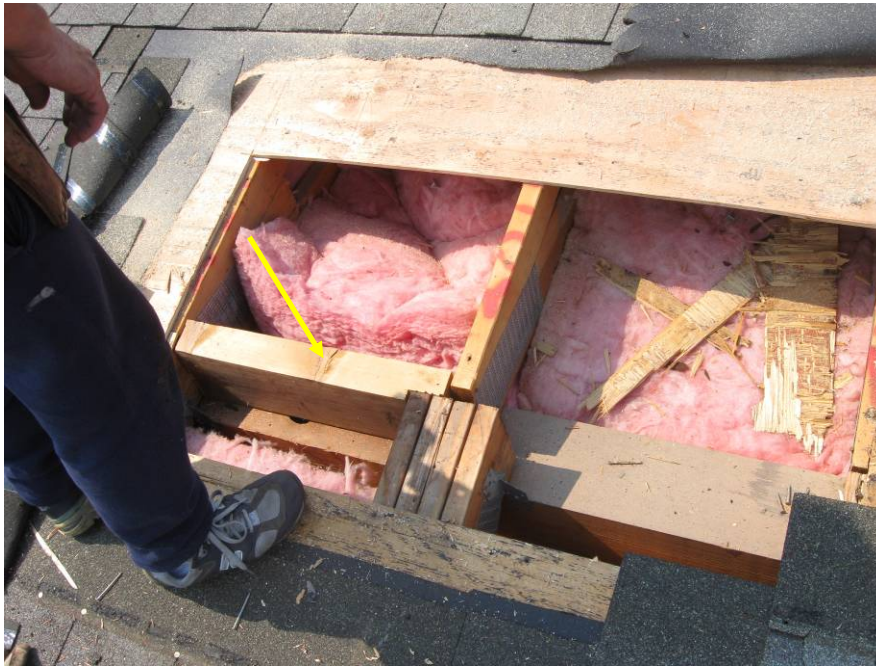
Photo #28

Roof opening #4 south slope, southwest roof area, field of roof, approximately 2 foot by 4 foot opening through the plywood deck, approximately 4 feet upslope of a valley transition: Wood blocking (arrow) installed over the beam at every other joist bay is restricting venting.

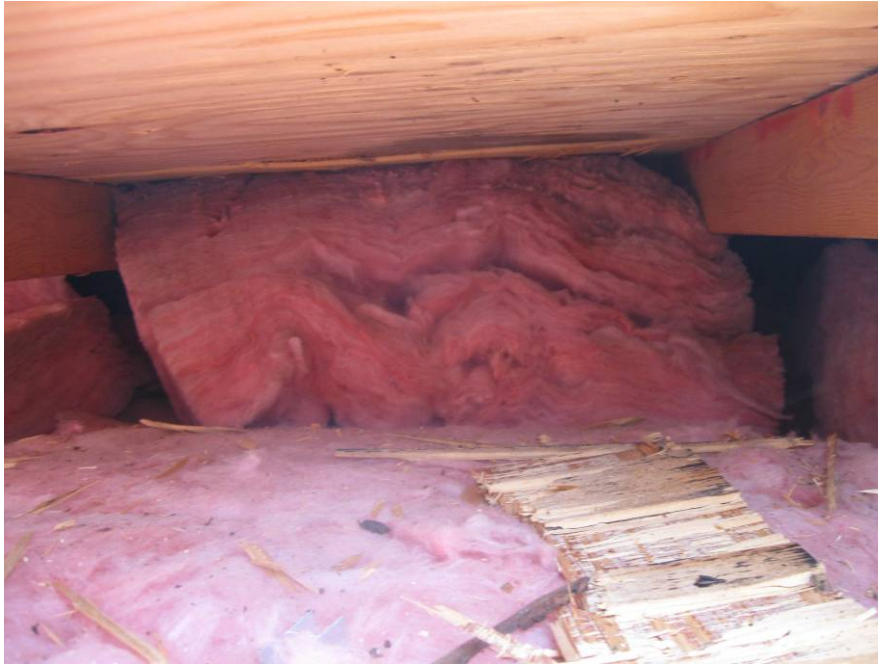
Photo #29

The vent cavity below the roof deck ranged from no gap (due to a raised piece of insulation) to approximately 8 inches.

Roof opening #4 south slope, southwest roof area, field of roof, approximately 2 foot by 4 foot opening through the plywood deck, approximately 4 feet upslope of a valley transition: Batt insulation upslope of the opening is blocking ventilation.

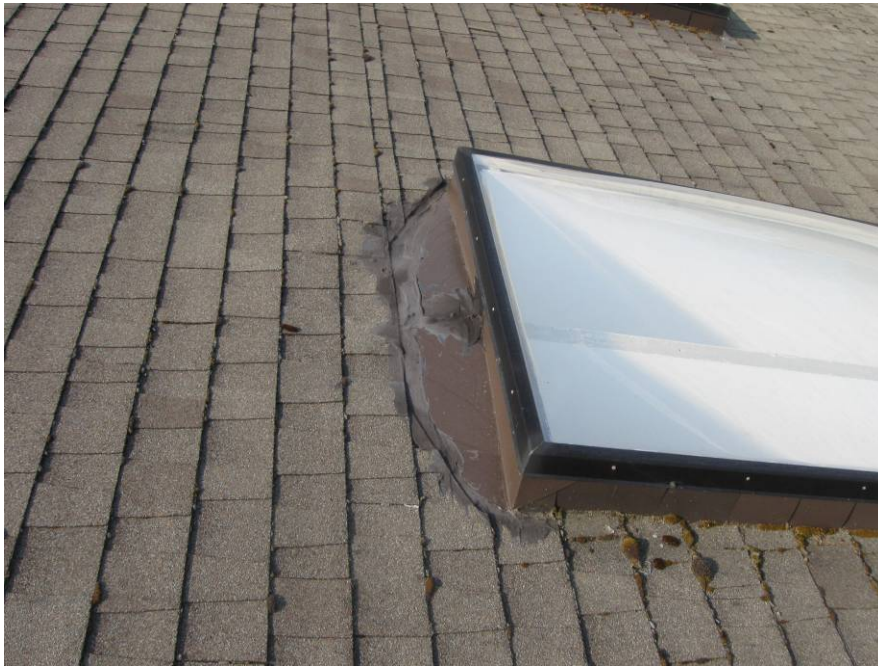
Photo #30

Roof penetrations predominantly consist of multiple skylights. The roof transitions at the upslope sides of the skylights include prefinished sheet metal crickets fabricated with lap seams, rivets, and sealant. Overall, the existing sheet metal curb flashings appear to be prone to leakage at corner and lap transitions which rely upon the integrity and longevity of the sealant installed.

2. Transition flashings and crickets installed at various skylight penetrations rely upon sealant (which may be deteriorated or lacking) at corner transitions and laps, and appear to be vulnerable to leakage.

Typical skylight penetration: Upslope cricket is consists of prefinished sheet metal that is reliant on sealant at the seams and transitions, and appears to be prone to leakage. Various maintenance/repair work has been performed on various penetrations flashings which typically includes application of sealant and asphalt roof cement.

Proper detailing and flashing transitions should occur at all penetrations, roof-to-wall transitions, and perimeter roof details. Continuous blocking would be required at the perimeter edges, matching the height of the rigid insulation. Skylight curbs, roof penetrations and roof-to-wall transitions will need to be raised to a minimum 8 inches above the finished roof plane.

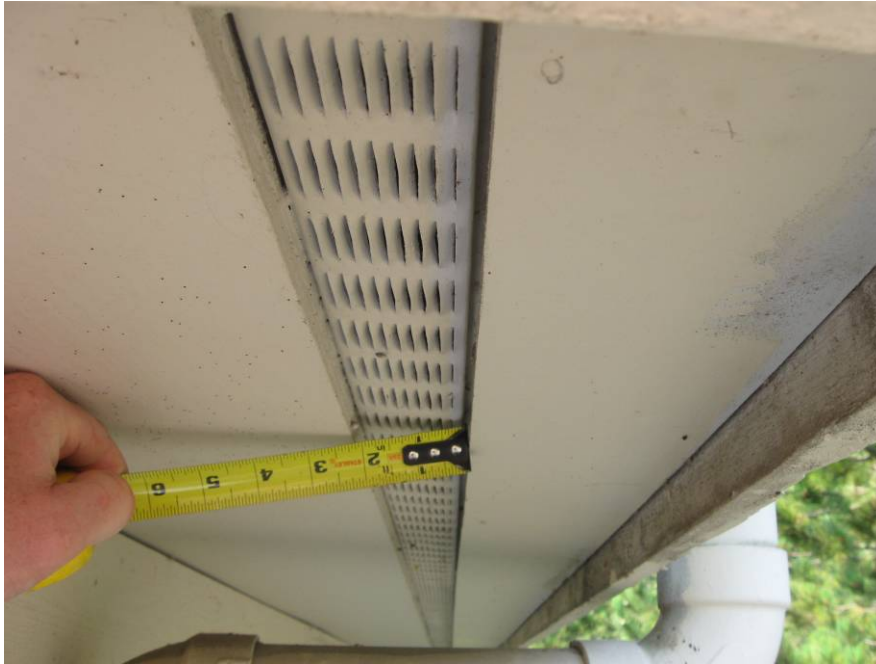
Photo #31

Venting details include a continuous 2 inch wide metal strip vent at the soffit and what appears to be a Cor-A-Vent 300 type continuous ridge vent, or similar with a fiberglass liner attached to the underside. While walking the underside of the perimeter soffit and pointing a flashlight directly into the strip vent, several stretches of the vent appeared to be plugged with batt insulation. This was confirmed during a roof opening performed near the eave.

Typical soffit vent includes a continuous ~2 inch strip vent. Several runs of strip venting at the soffit appear to be blocked with batt insulation.

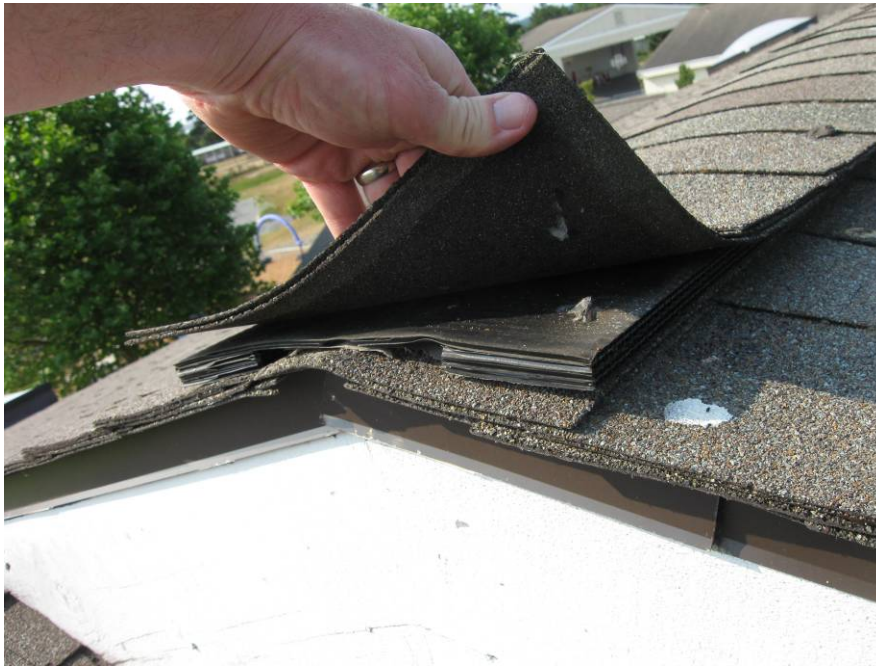
Photo #32

Typical ridge vent includes what appears to be a Cor-a-vent 300 or similar which includes a fiberglass liner on the underside.

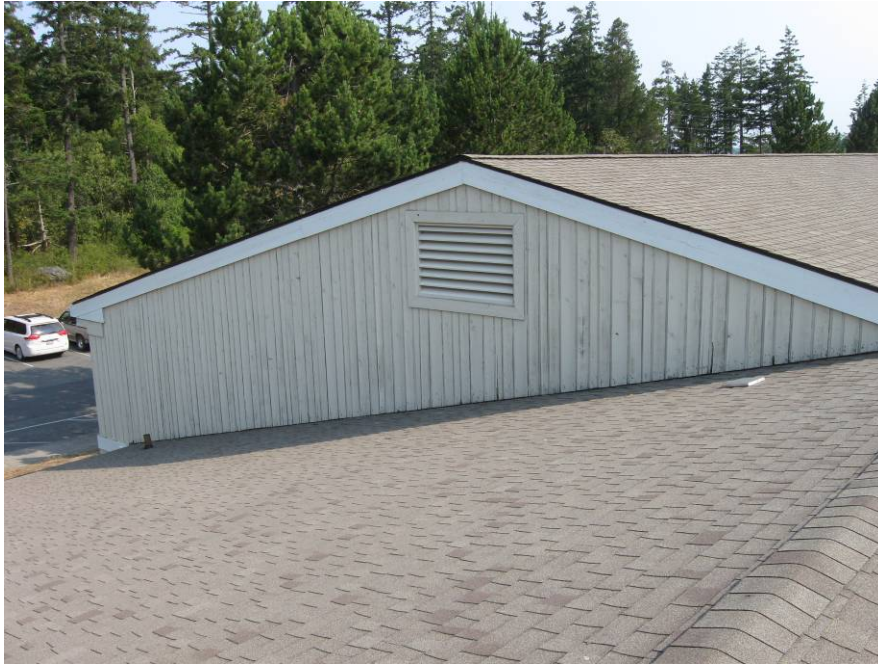
Photo #33

Typical roof-to-wall transition: Several areas of the wood siding are deteriorated and may be open to water entry during wind-blown rain.

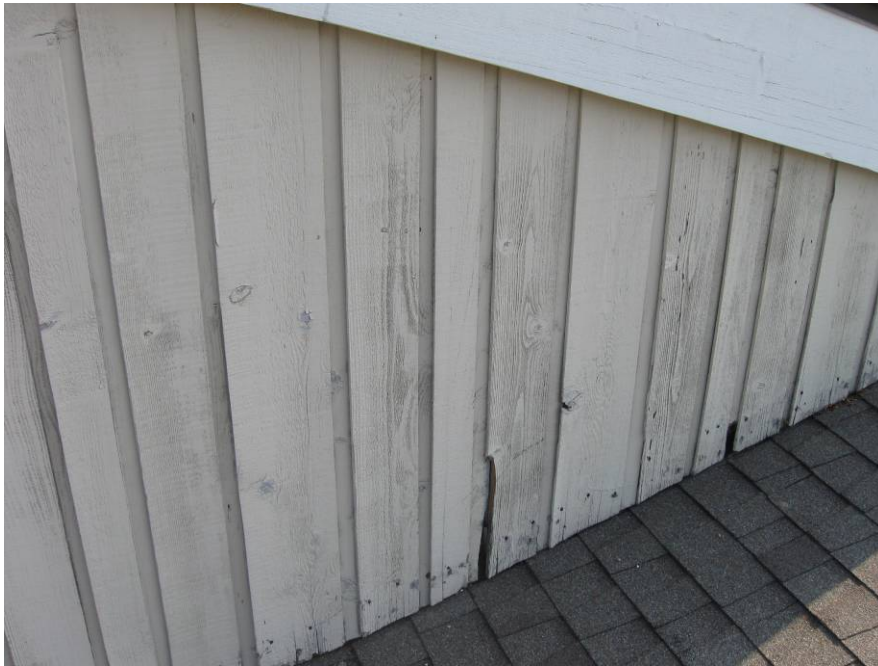
Photo #34

Typical roof-to-wall transition: Several areas of the wood siding are deteriorated and may be open to water entry during wind-blown rain.

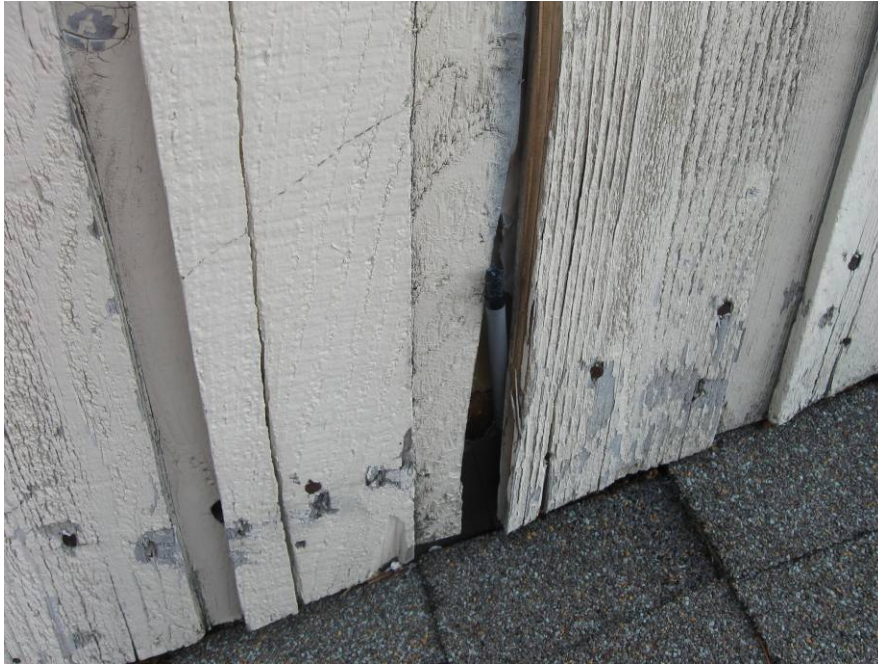
Photo #35

Roof-to-wall detailing at typical roof step-up transitions include metal step flashing integrated with the shingles (typically on a one-to-one basis) and integrated with the wood siding. Where the vertical legs of the step flashing were visible through an open gap in the wood siding, it was noted that the existing asphalt saturated building paper was reverse lapped with the step flashing. Deterioration of the wood siding was noted at several areas.

Typical roof-to-wall transition: Several areas of the wood siding are deteriorated and may be open to water entry during wind-blown rain. Note the step flashing is not properly integrated with the weather resistant barrier (behind the siding) in shingle fashion.
